**PILE DRIVERS
LOCAL UNION 56**

PHOTOS- CRANES AND DERRICKS ON BARGES

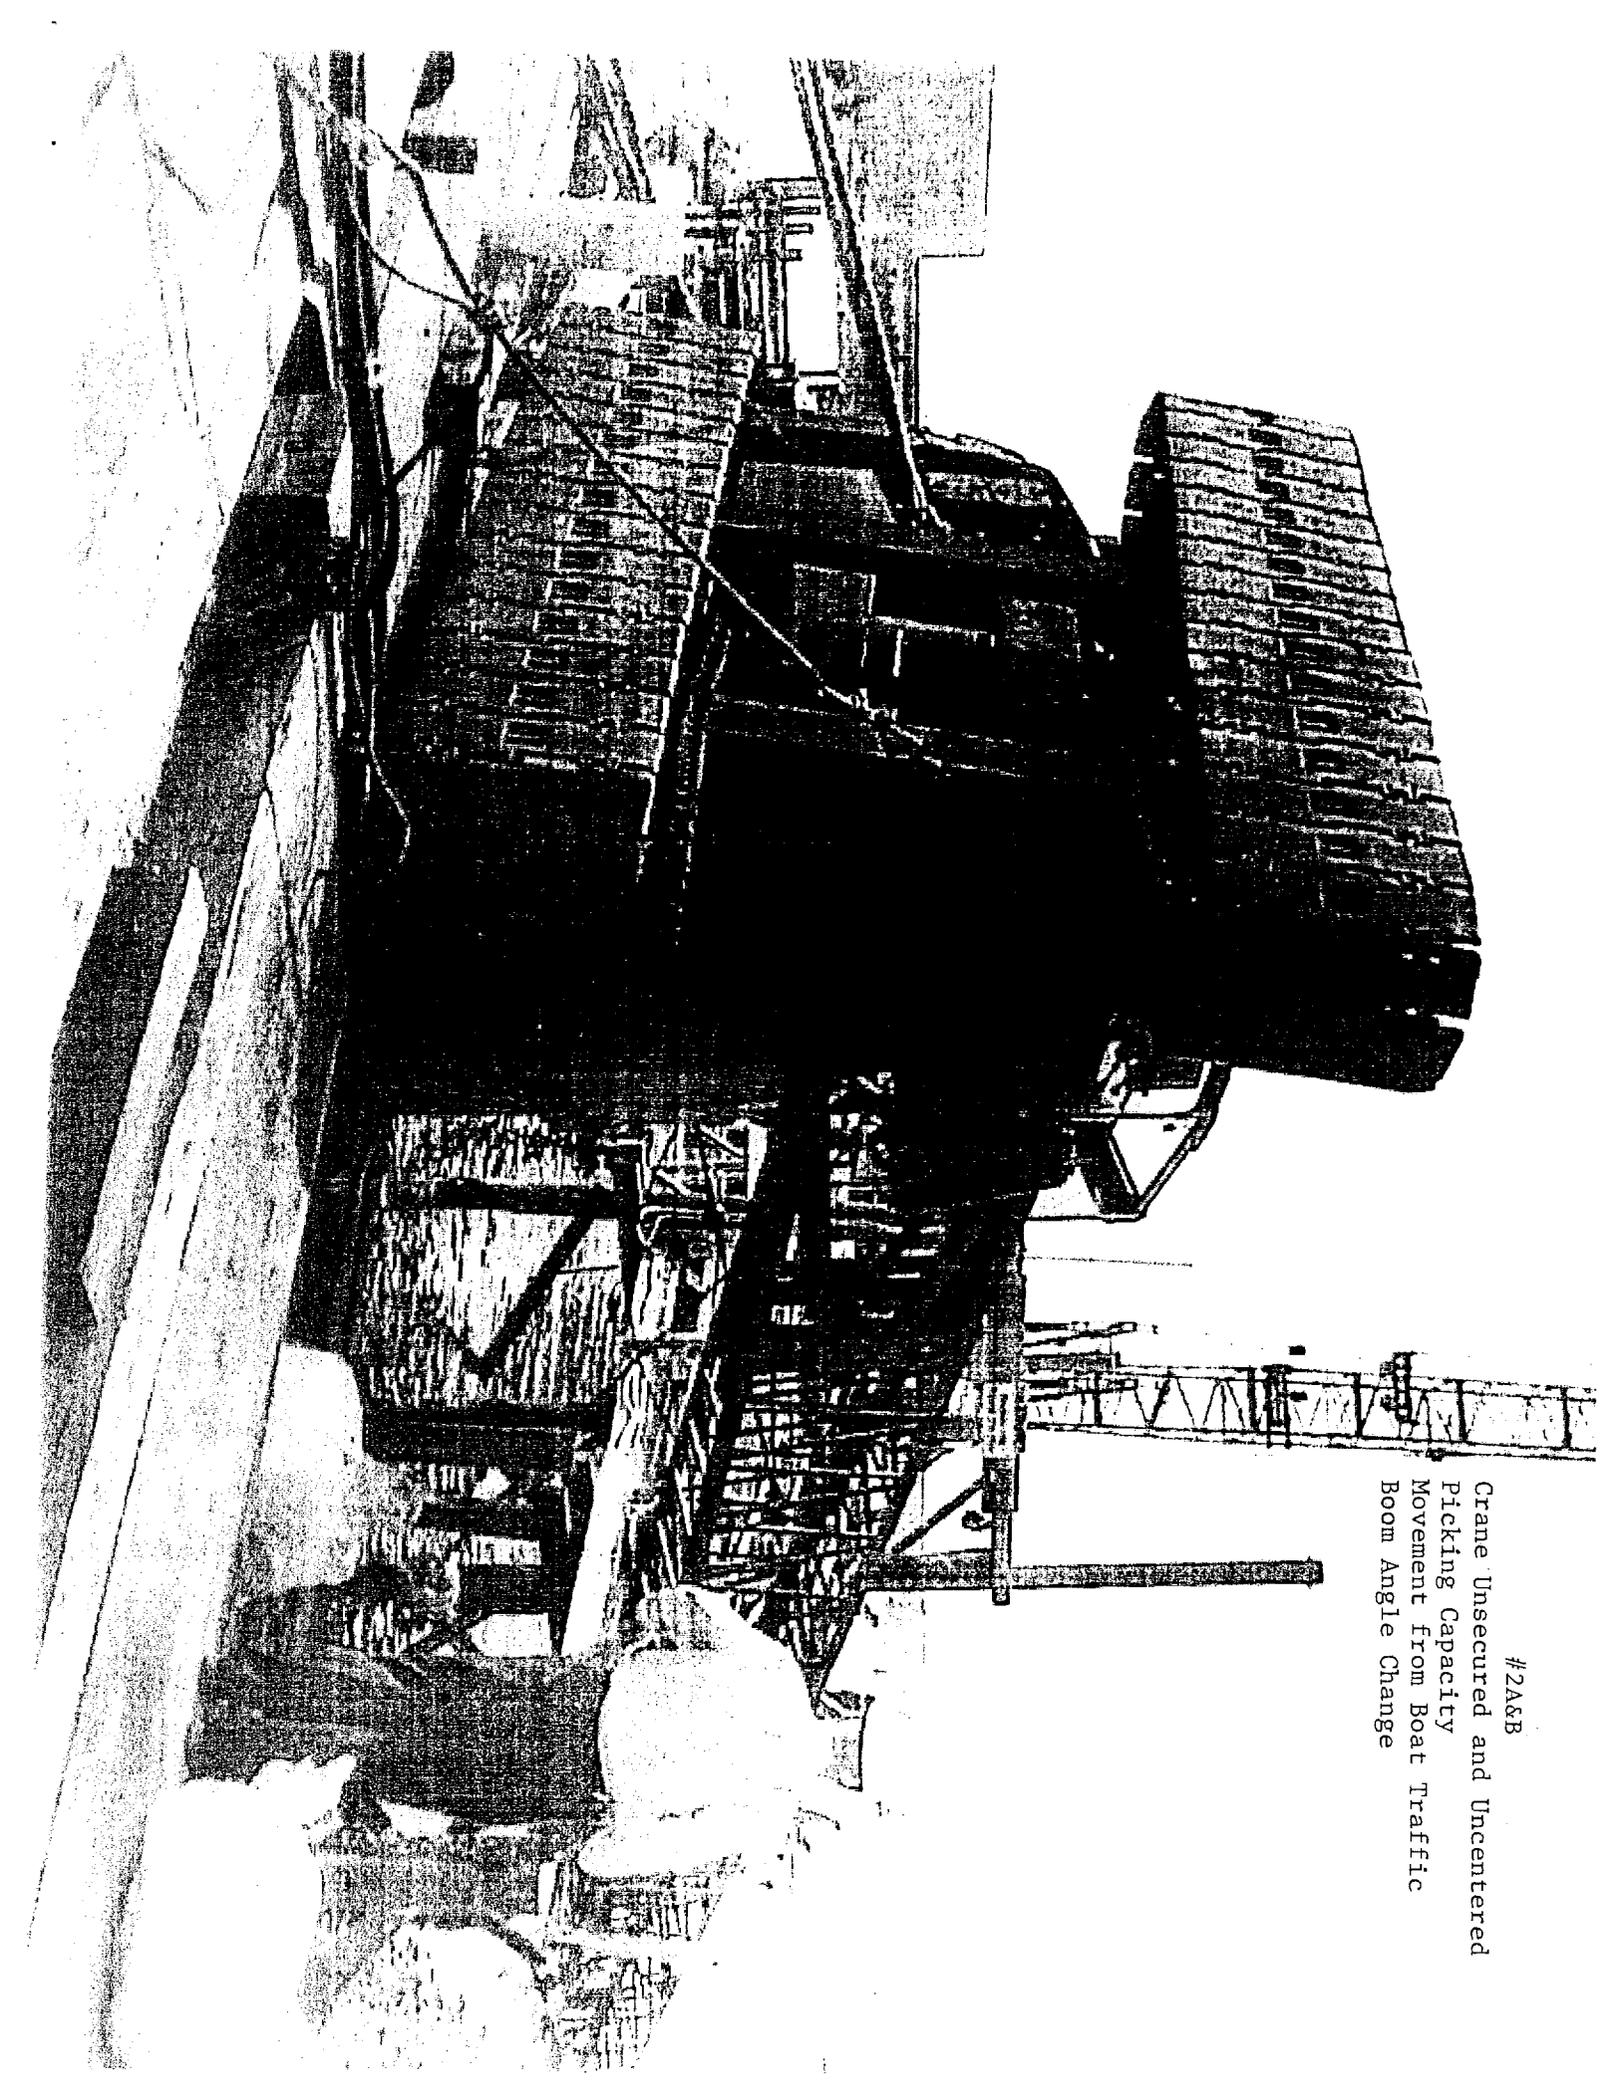
#2A&B
Crane Unsecured and Uncentered
Picking Capacity
Movement from Boat Traffic
Boom Angle Change

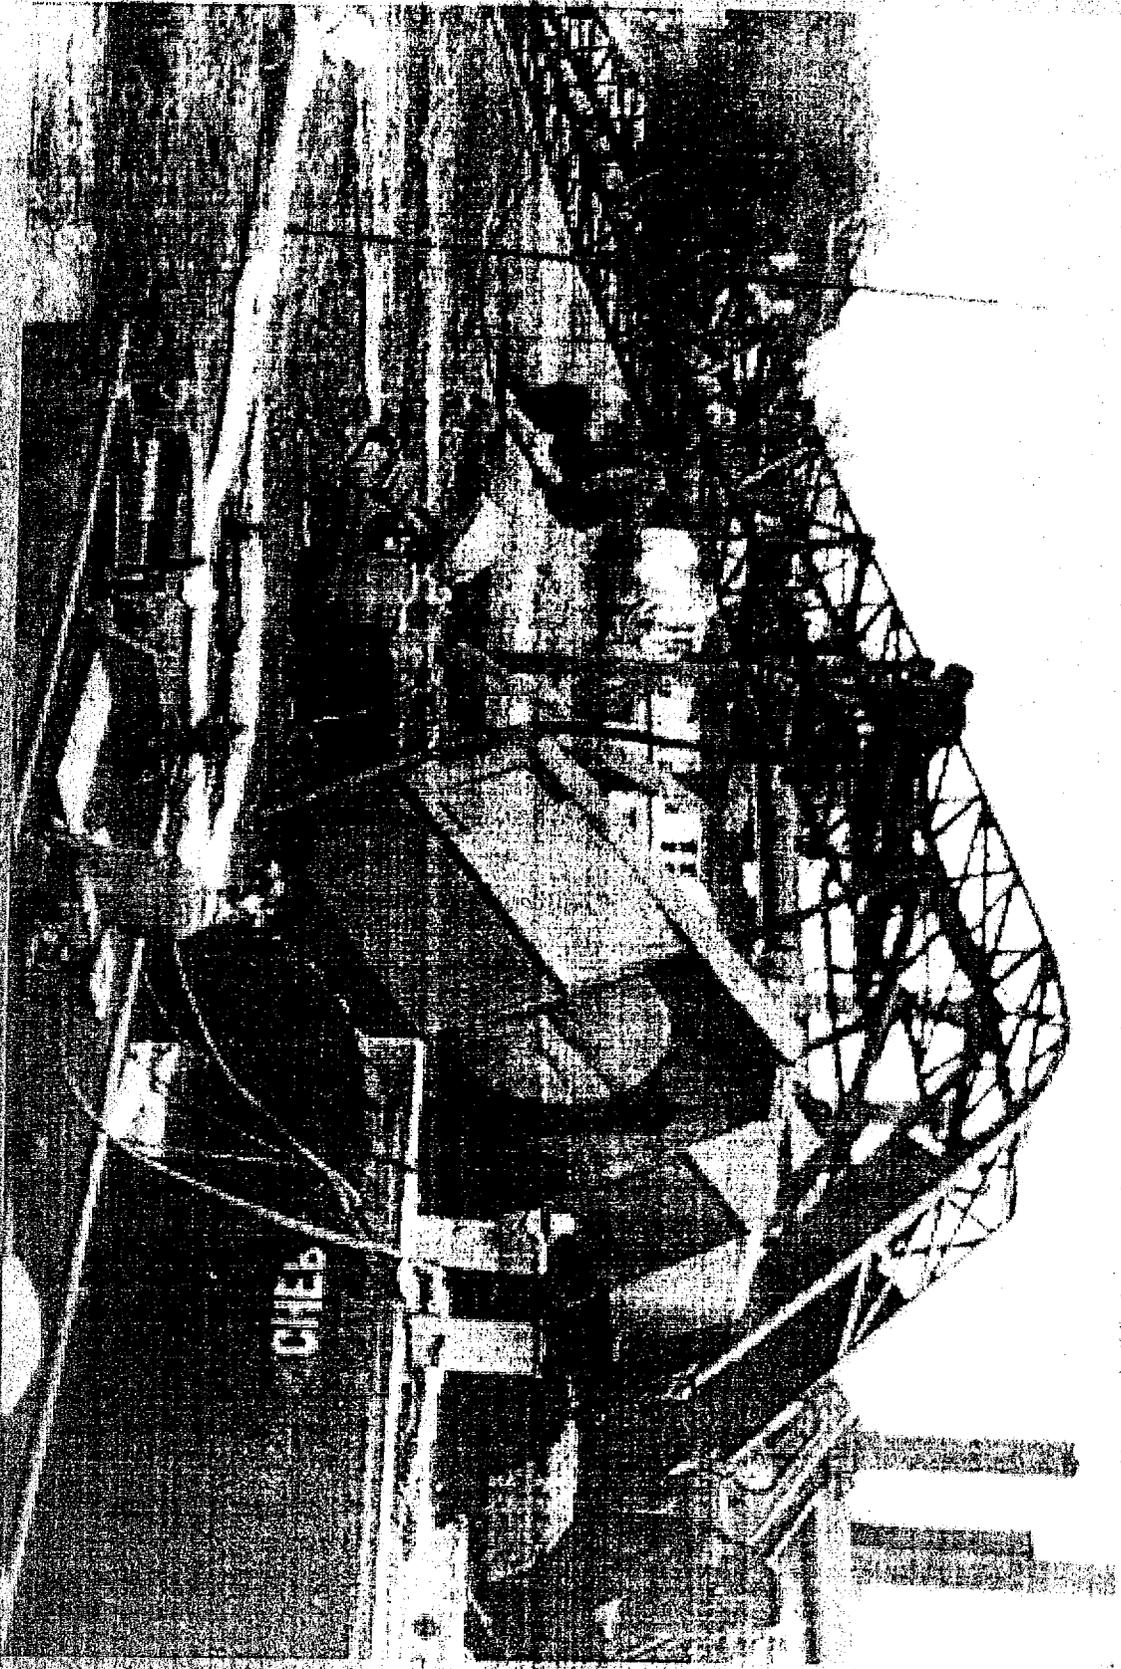
#3B

#3A&B
Crane Unsecure - Unattended
Frictions Engaged
Crane Walked Off Barge

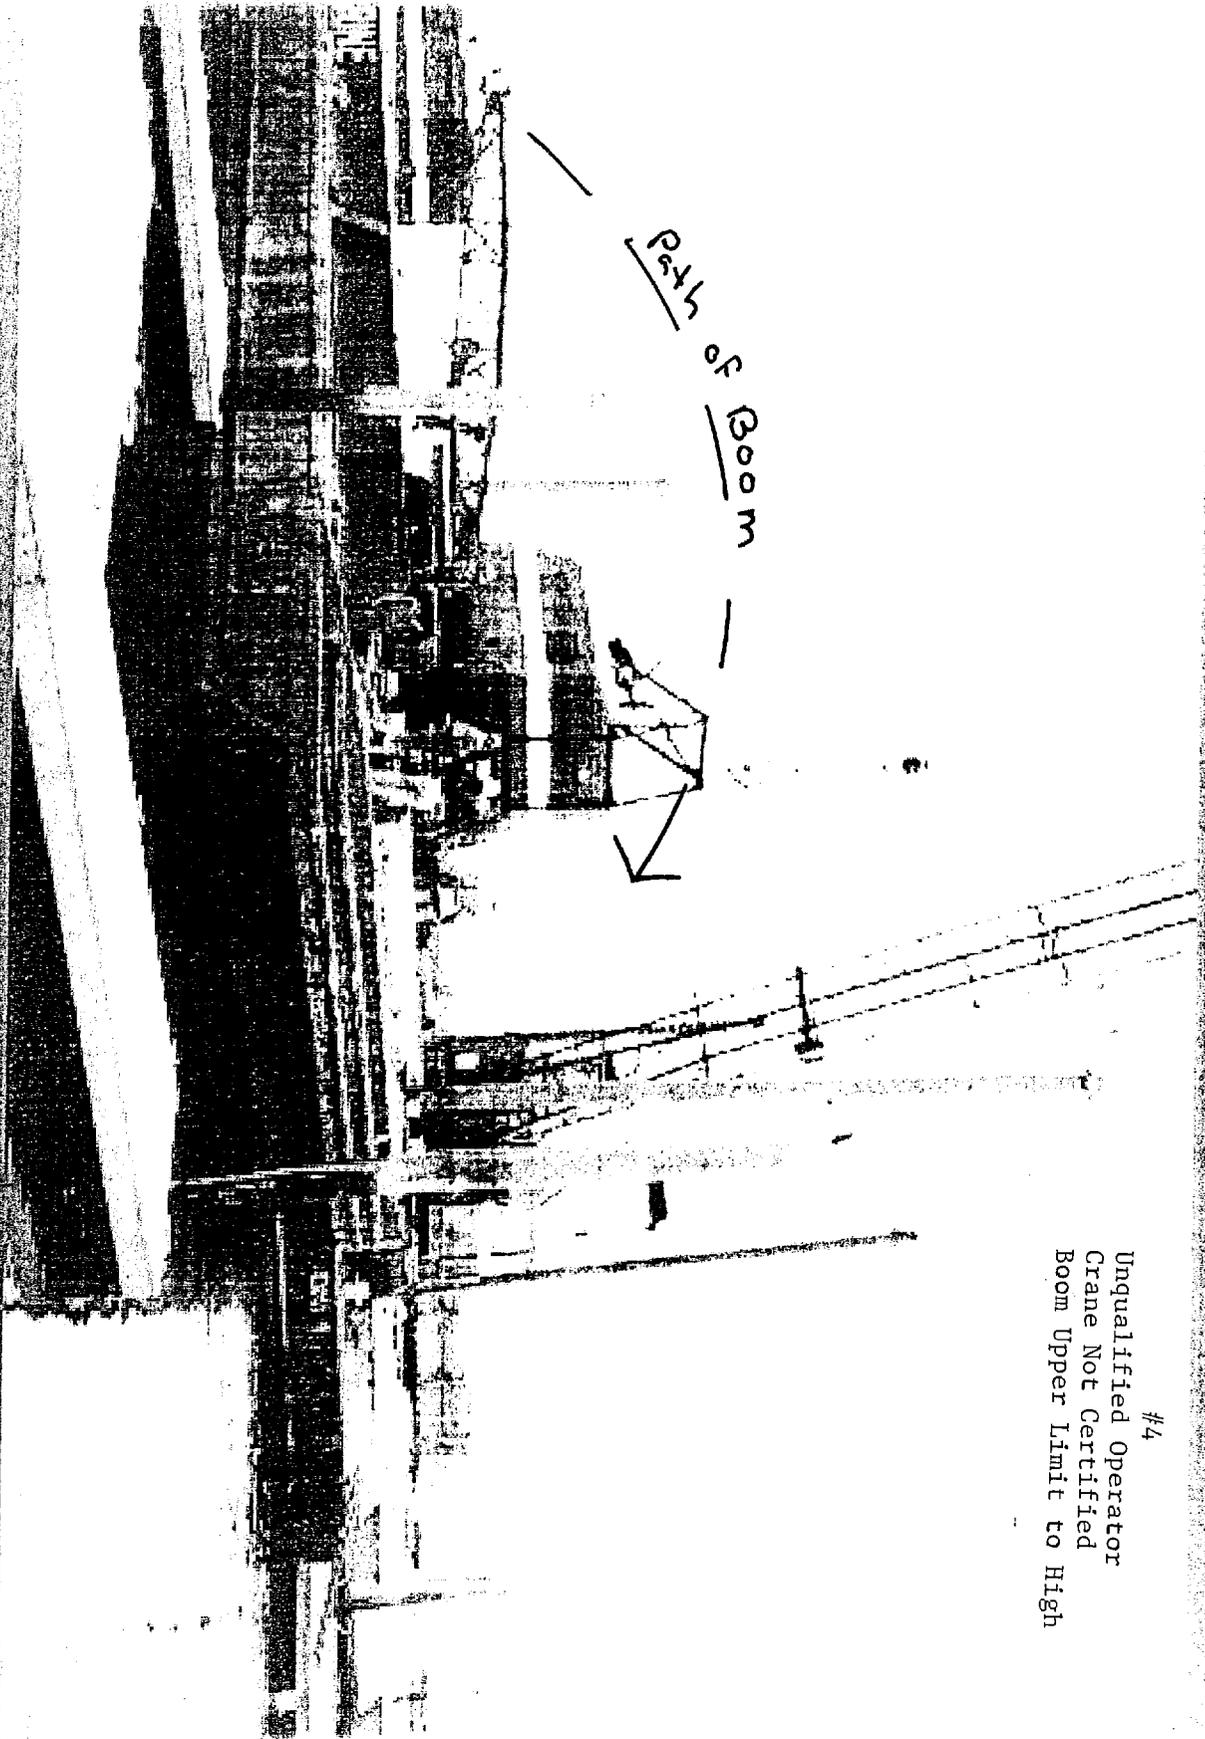
#4
Unqualified Operator
Crane Not Certified
Boom Upper Limit to High
